**INTERNATIONAL  
MATERIALS  
HANDLING  
CONFERENCE**

## ***BELTCON 3***

Visual Scanning of Steel Reinforced Conveyor Belting

A.J.v.d.WALT - Director  
Melco Mining Supplies (Pty) Ltd.  
Germiston  
South Africa

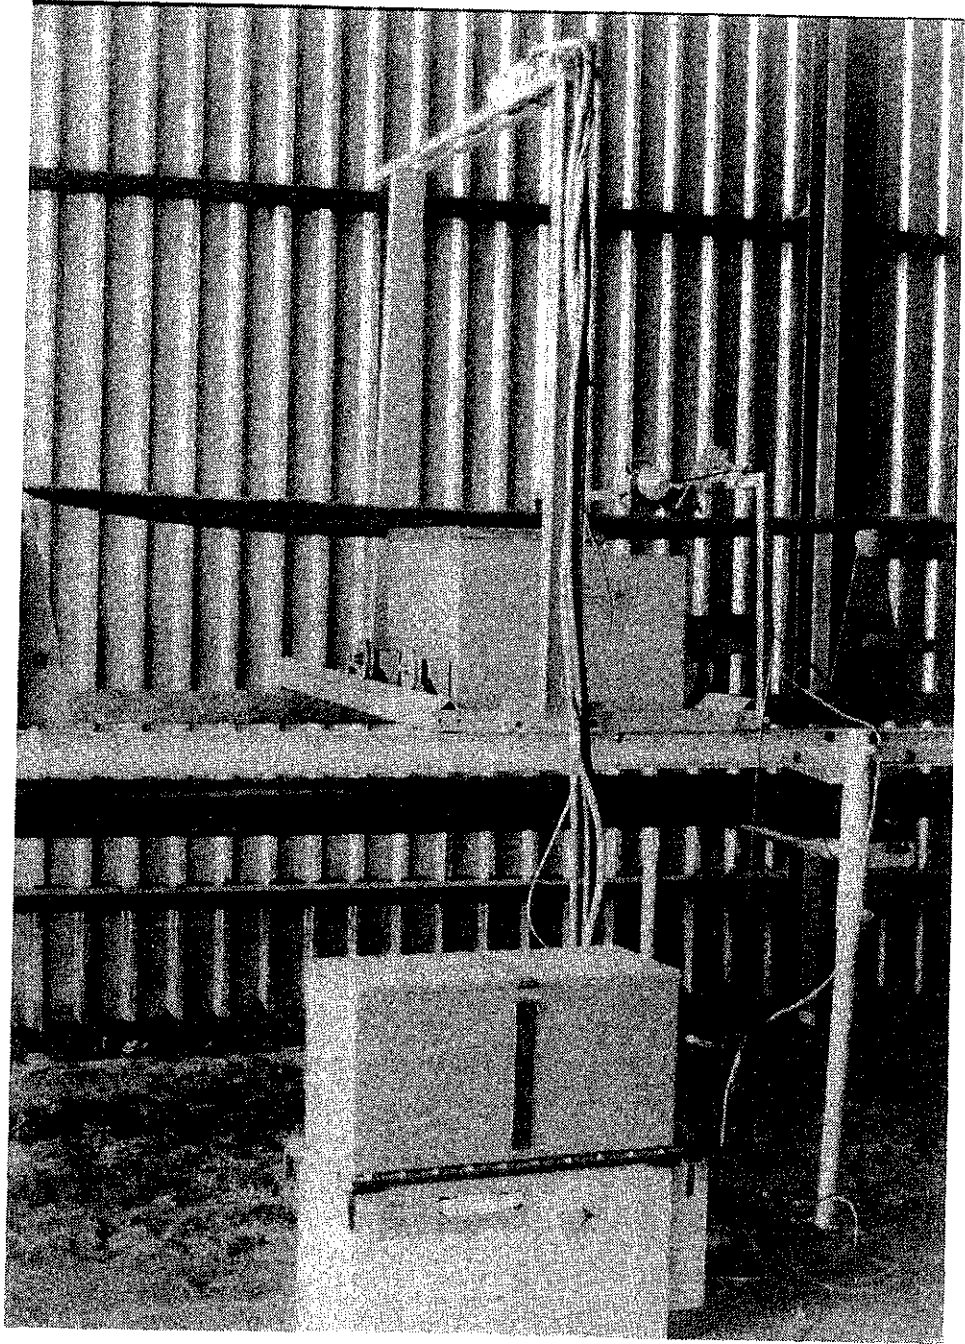
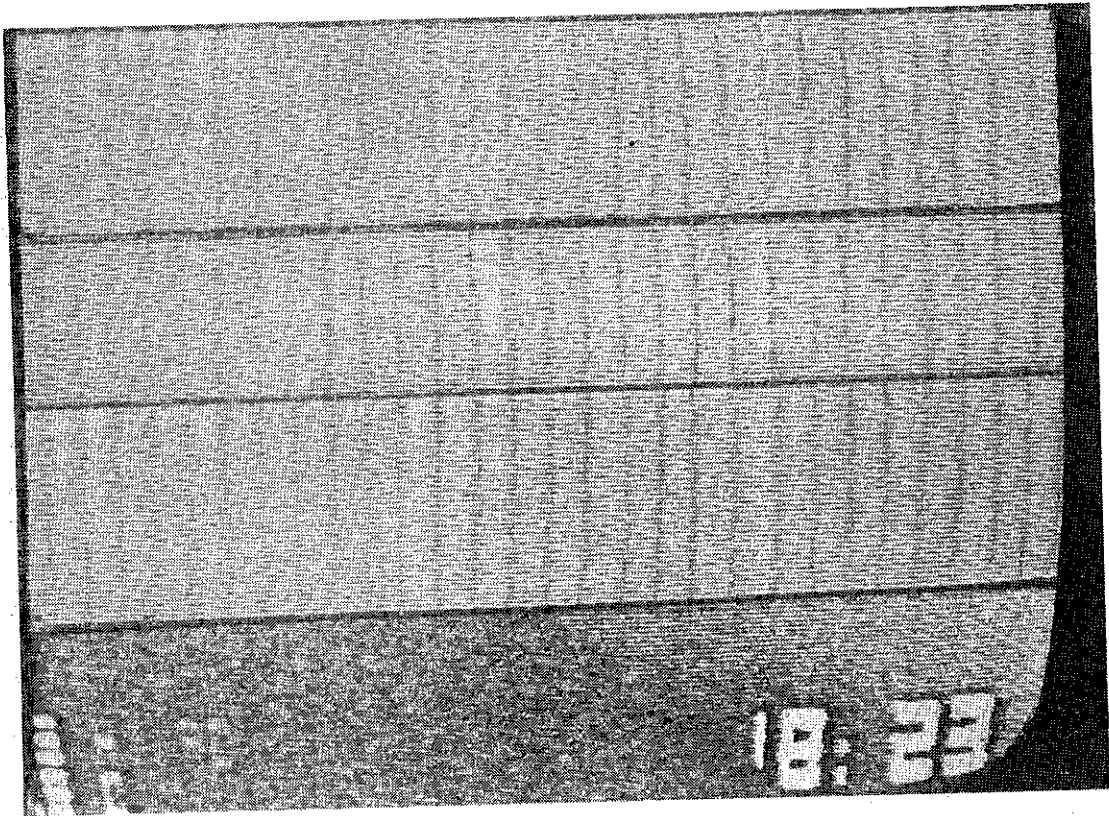
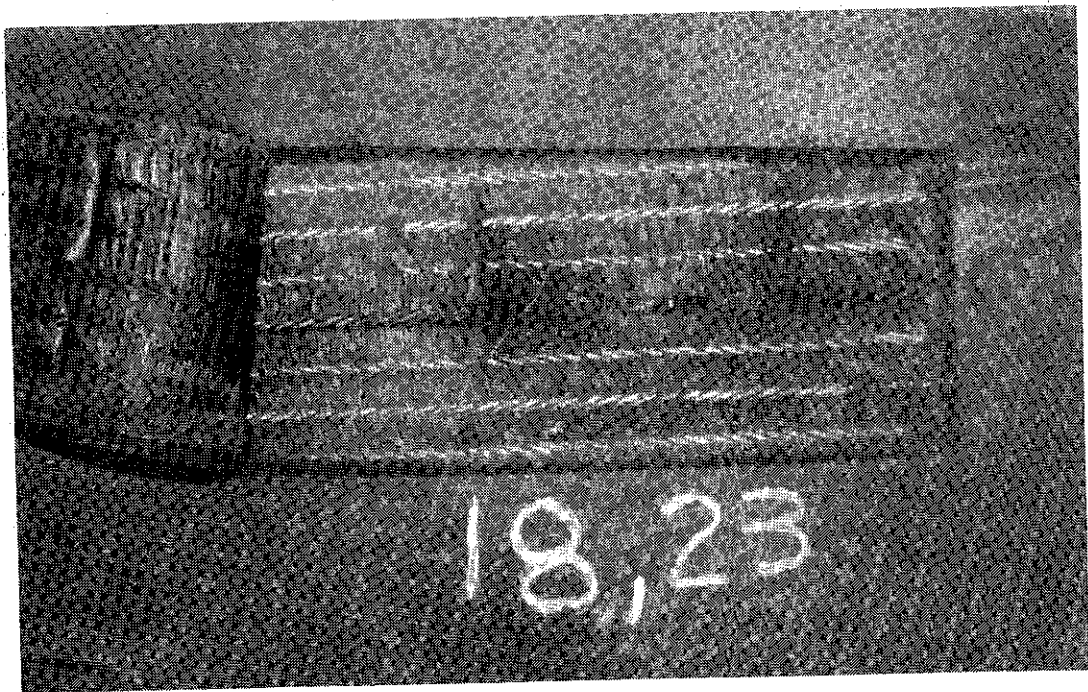
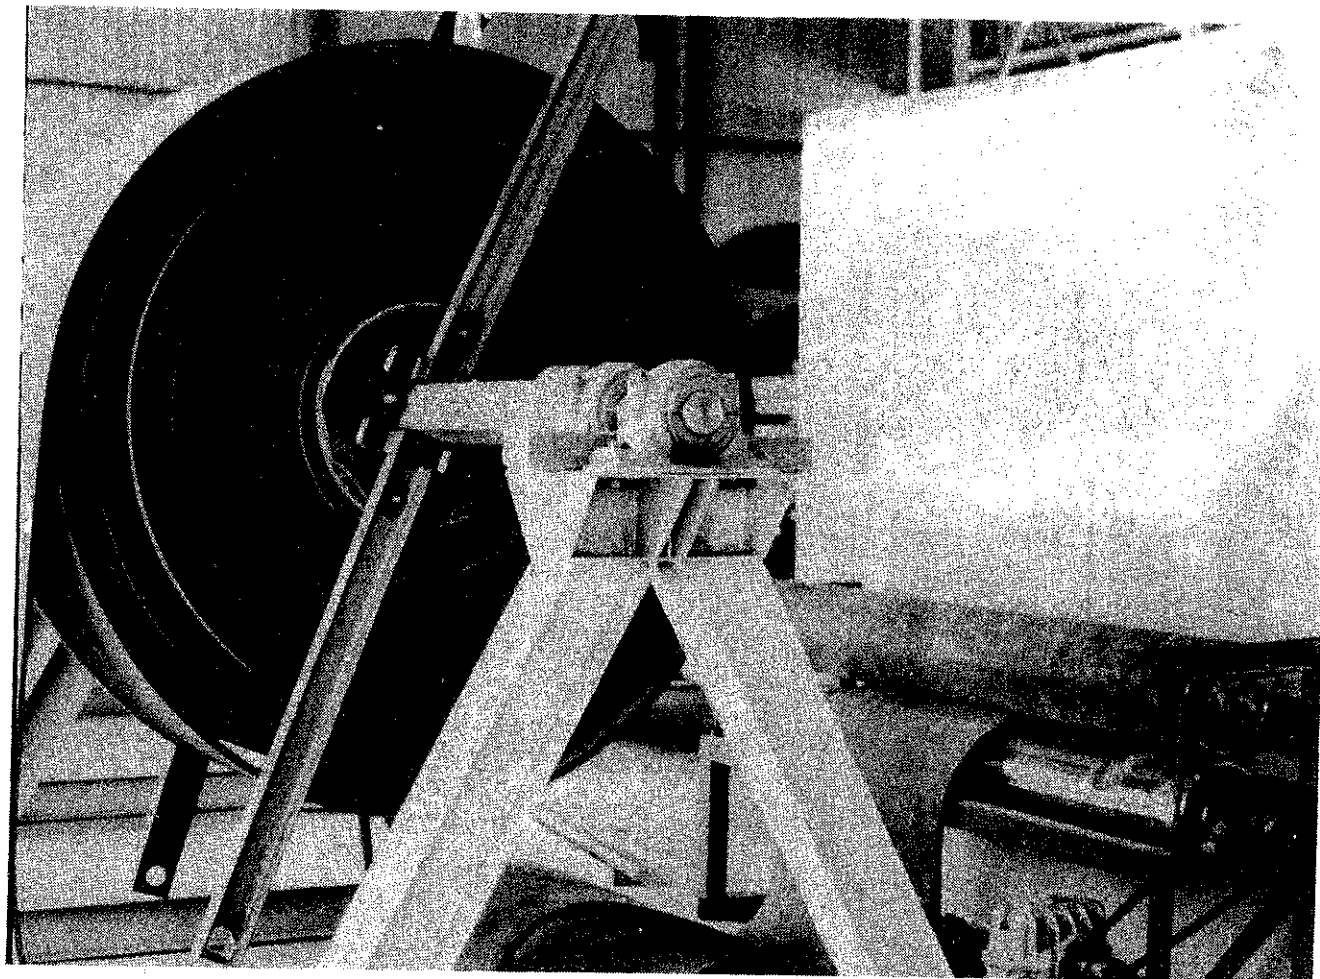
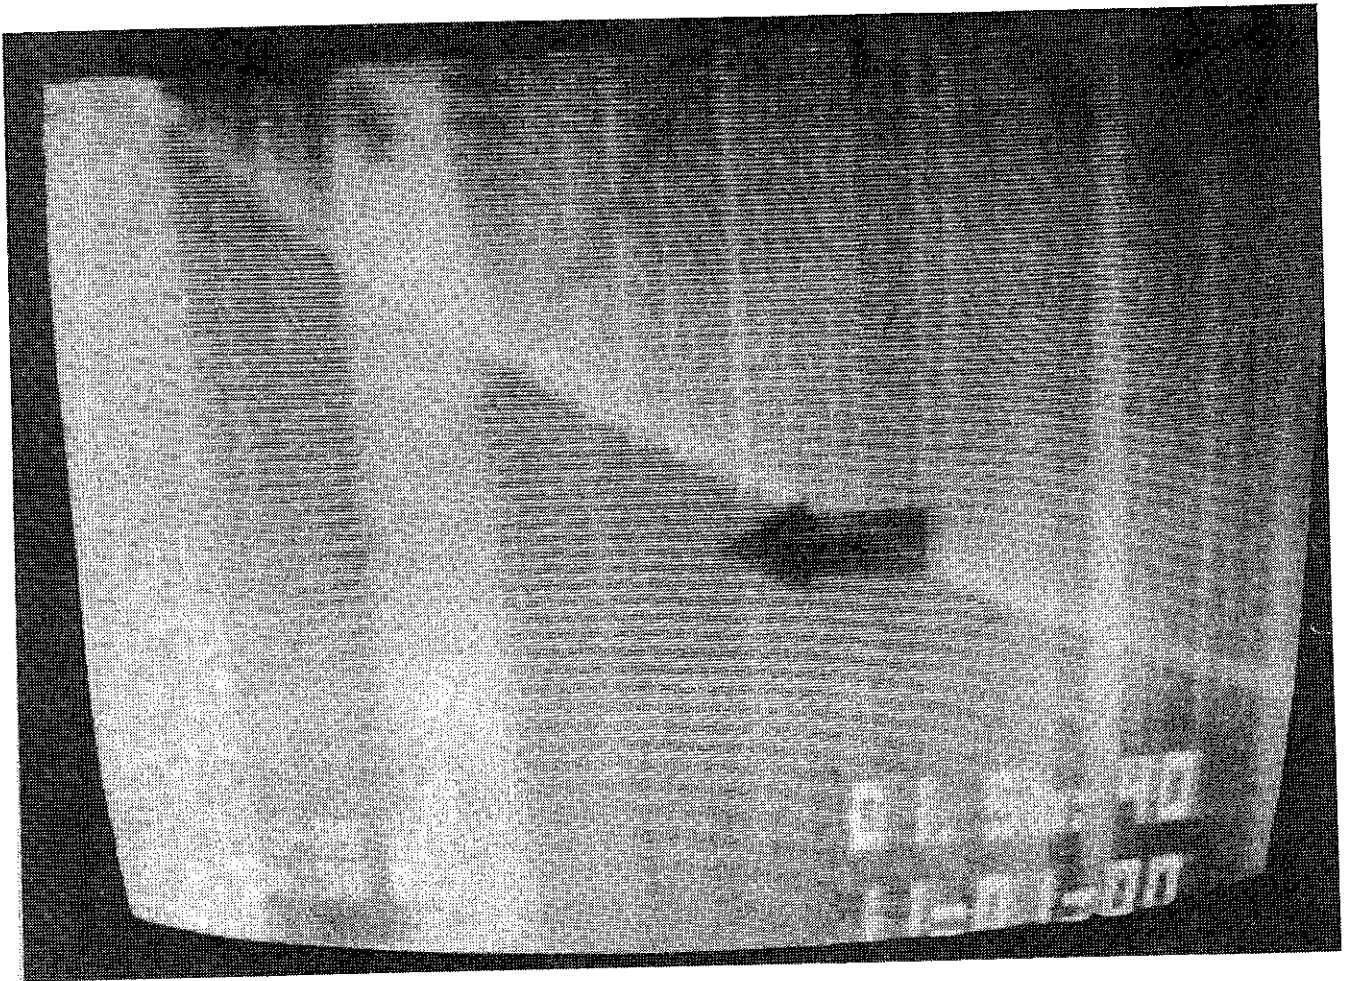
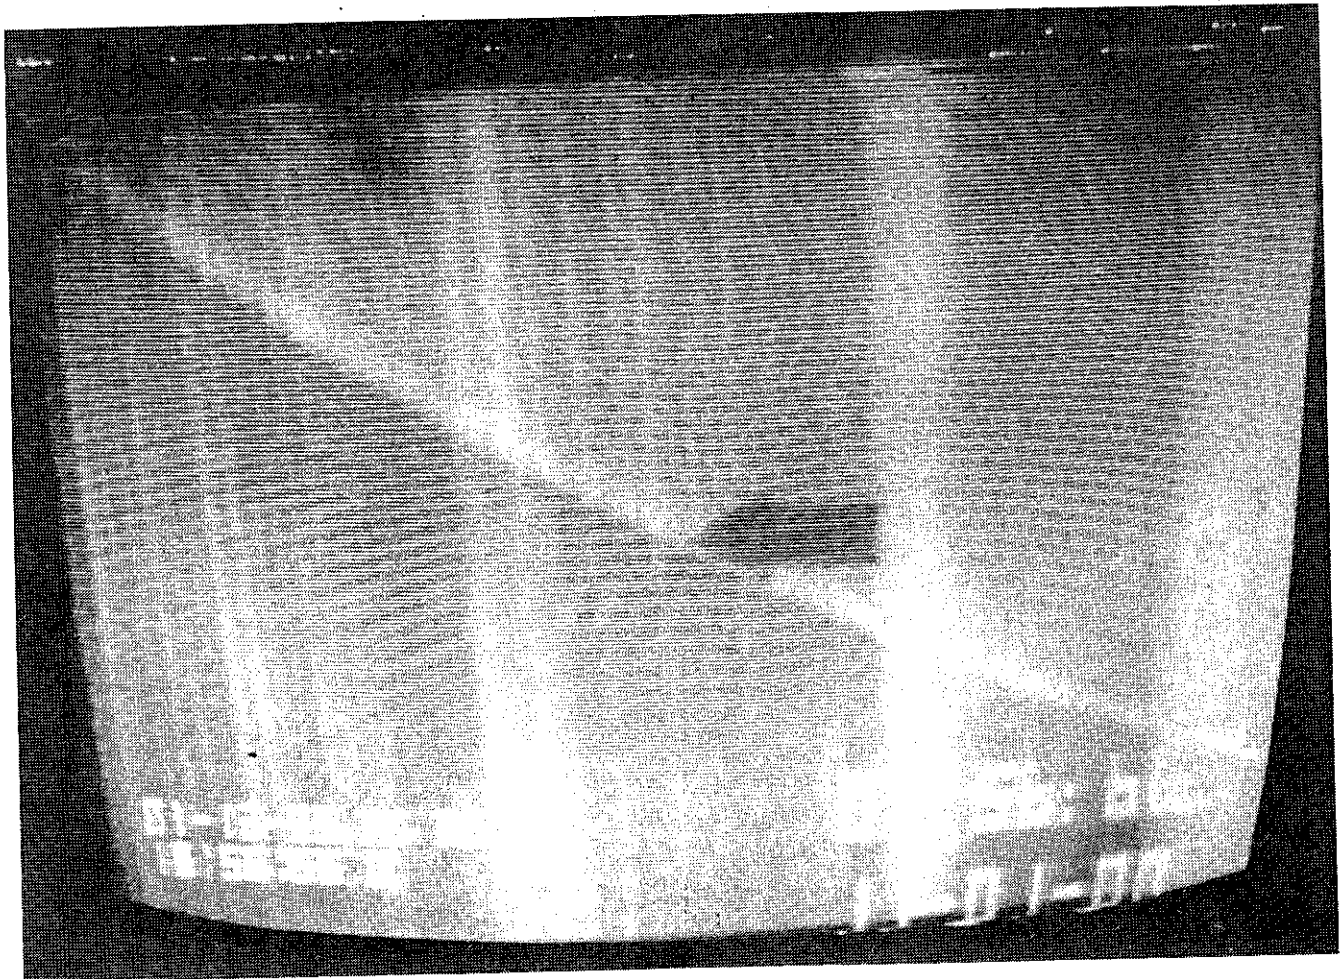
With the factory unit a split image on the screen allows visual inspection of the whole belt width in a single pass whereas with the portable unit each pass scans 650mm. Thus for a belt width between 750mm and 1200mm two scans are required. For belt widths between 1350mm and 1800mm three scans, and so forth.

A datum line is used from where all deviations from the norm can be located by measurement for corrective action.

The method consists of either moving the belt through the unit or moving the unit over the belt depending on the need.

It can be installed on the carrying or on the return side to suit conditions.

The image of the carcass is continuously taped during the monitoring process and can be examined frame by frame if necessary, on completion.

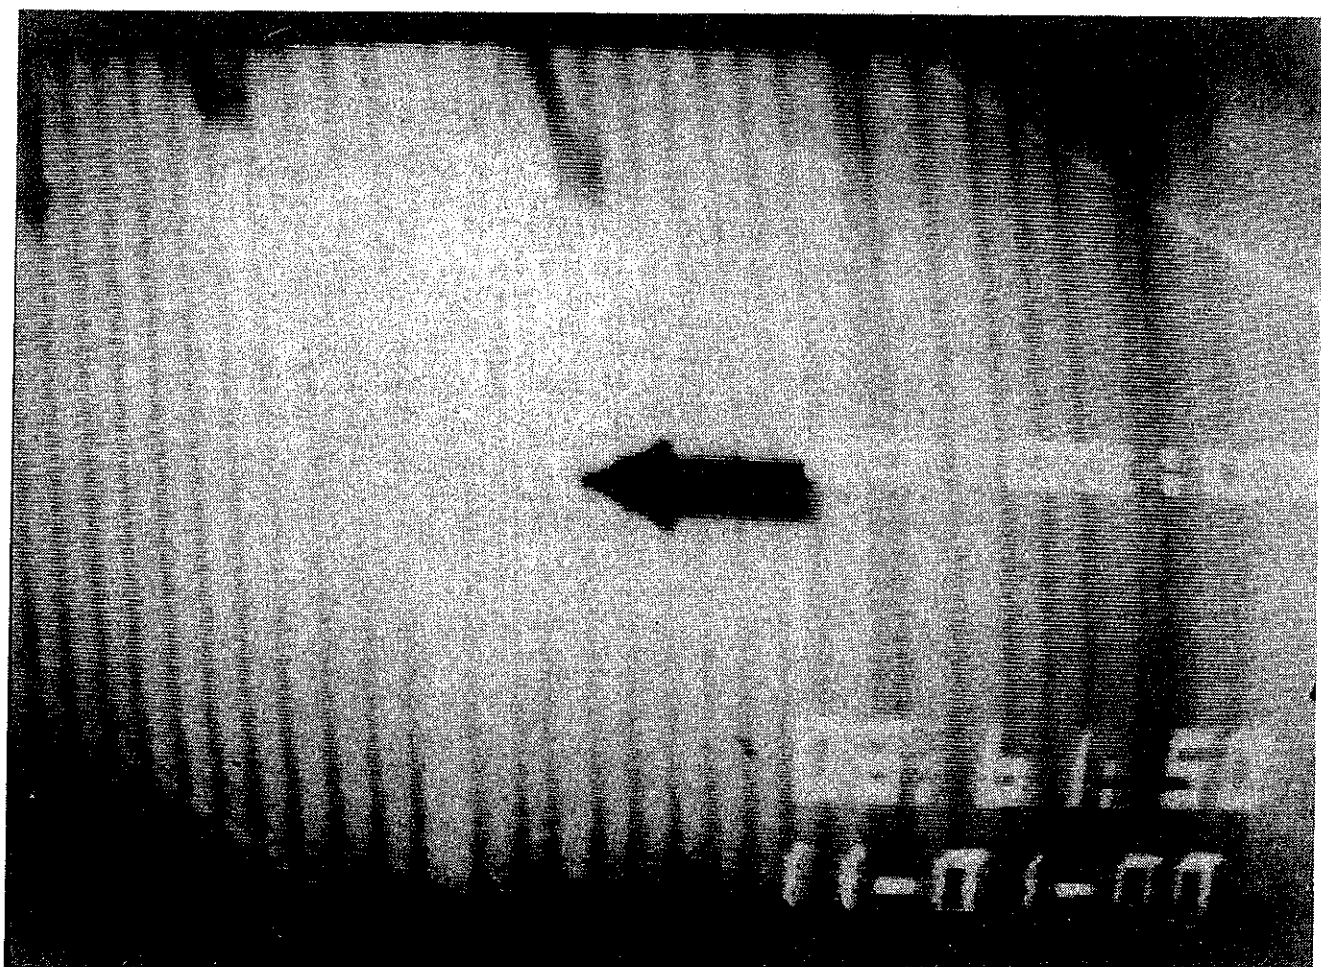
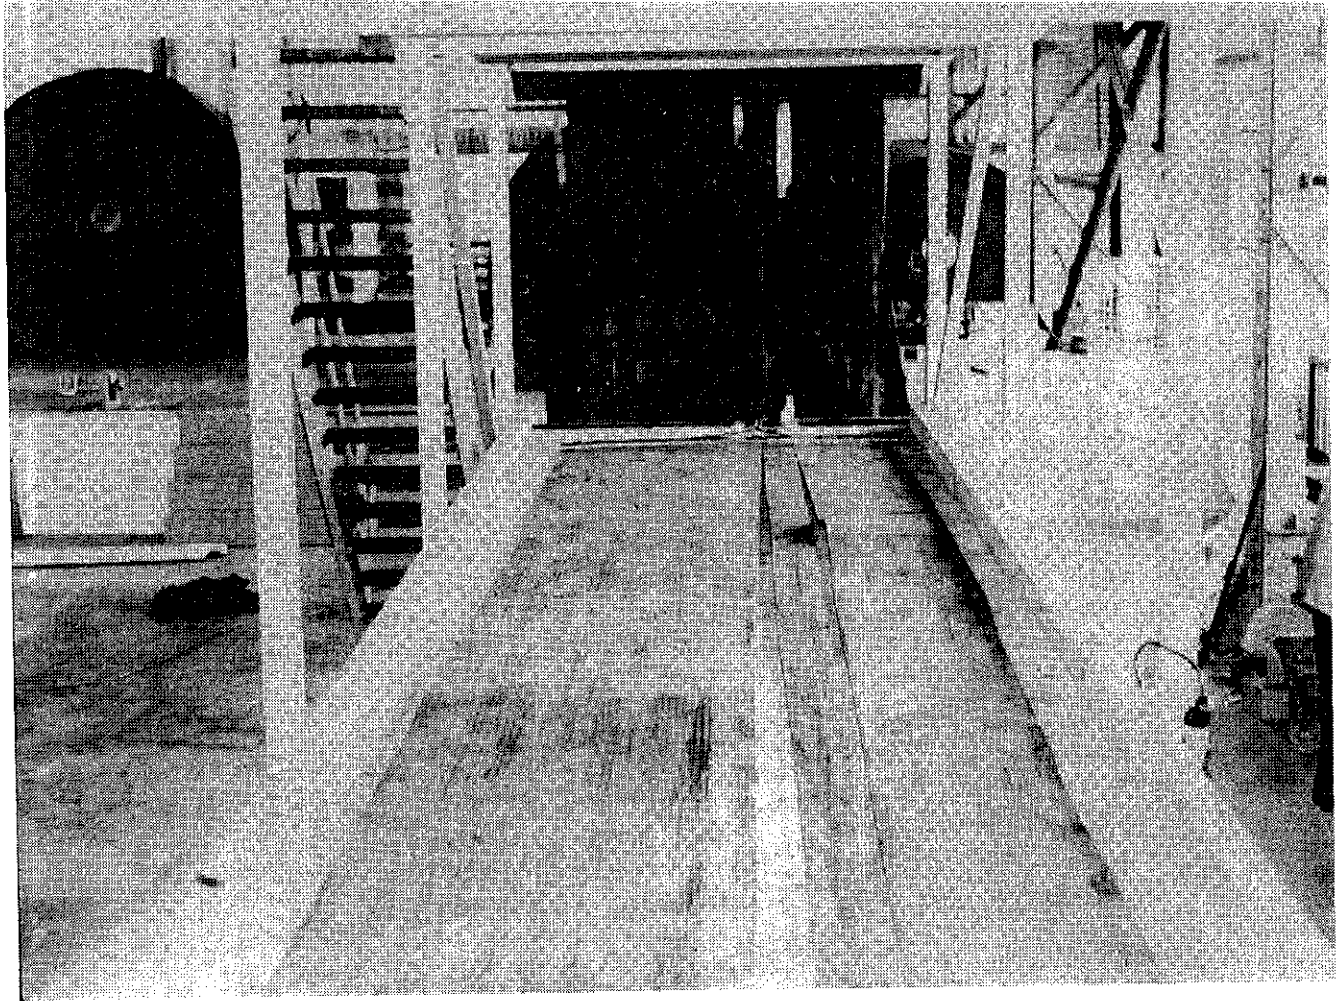
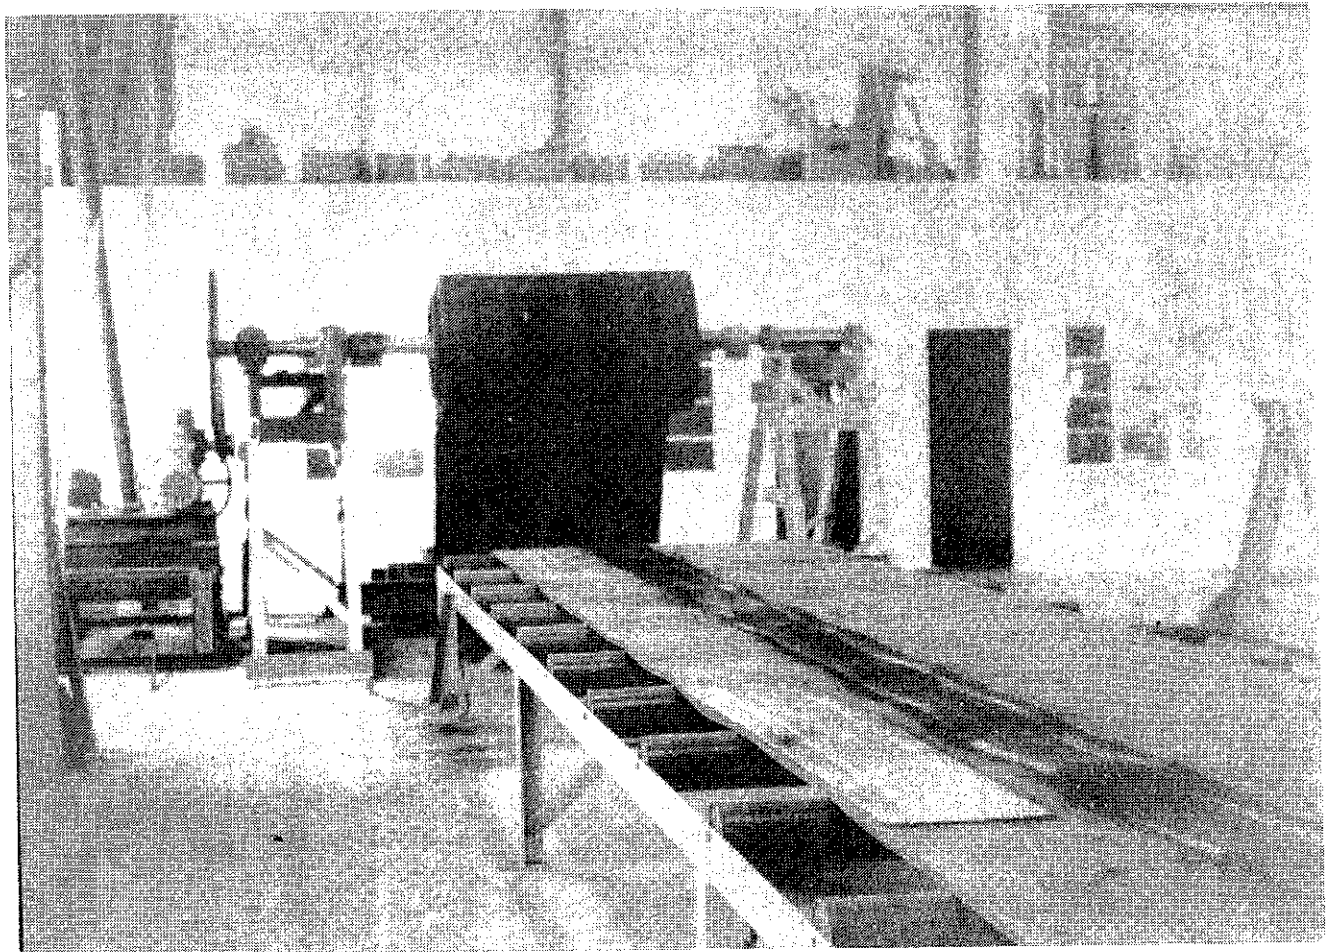
##### 4.1 HORIZONTAL CABLE DISPLACEMENT

Steel cord re-inforced conveyor belt is manufactured to certain specifications one of which limits the variation in horizontal pitch between cables.

- a) Does the horizontal displacement cause a maldistribution of tensions across the belt?
- b) Does this maldistribution cause training problems?
- c) Is there a breakdown of cable to gum adhesion in these areas?

These are some of the potential problems that can be caused by horizontal cable displacement.
